County of San Luis Obispo Onsite Environmental Coordinator
Guadalupe Update 7-24-2017

Construction/remediation activities continue at the Chevron Guadalupe Oil Field Remediation Site (Field) this week. The San Luis Obispo County Onsite Environmental Coordinator (OEC) continues to be present at the Field on a daily basis.

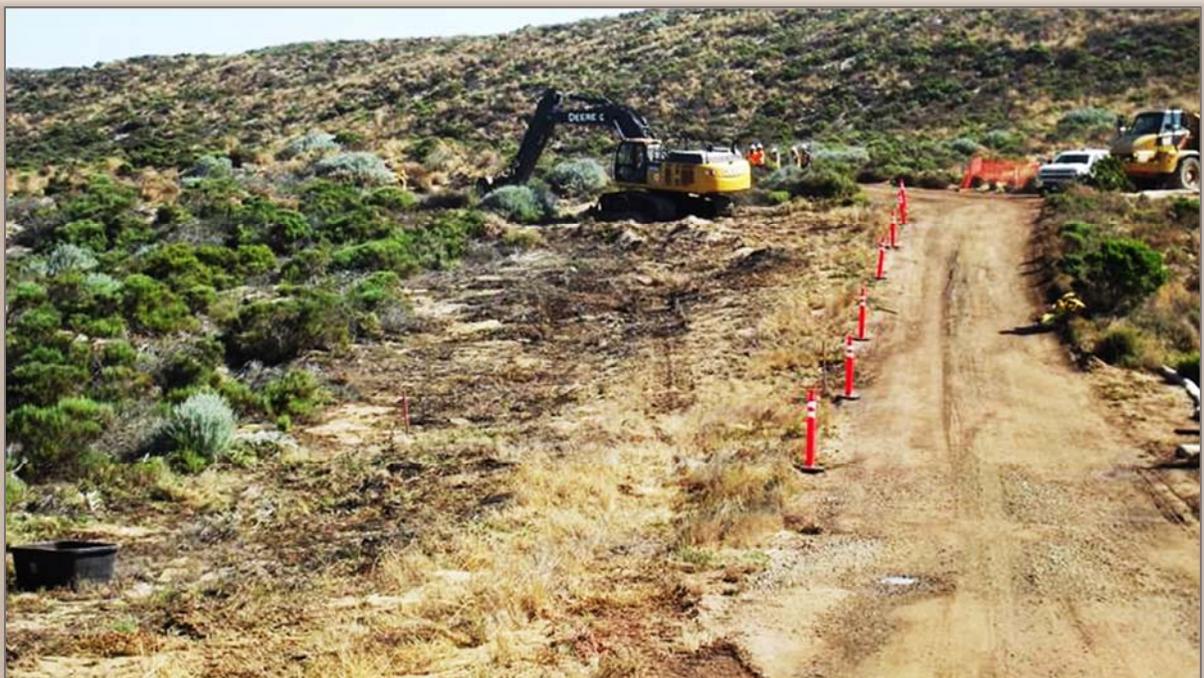
J5A PROS Remediation Site: Chevron contractors beginning to excavate sump material.

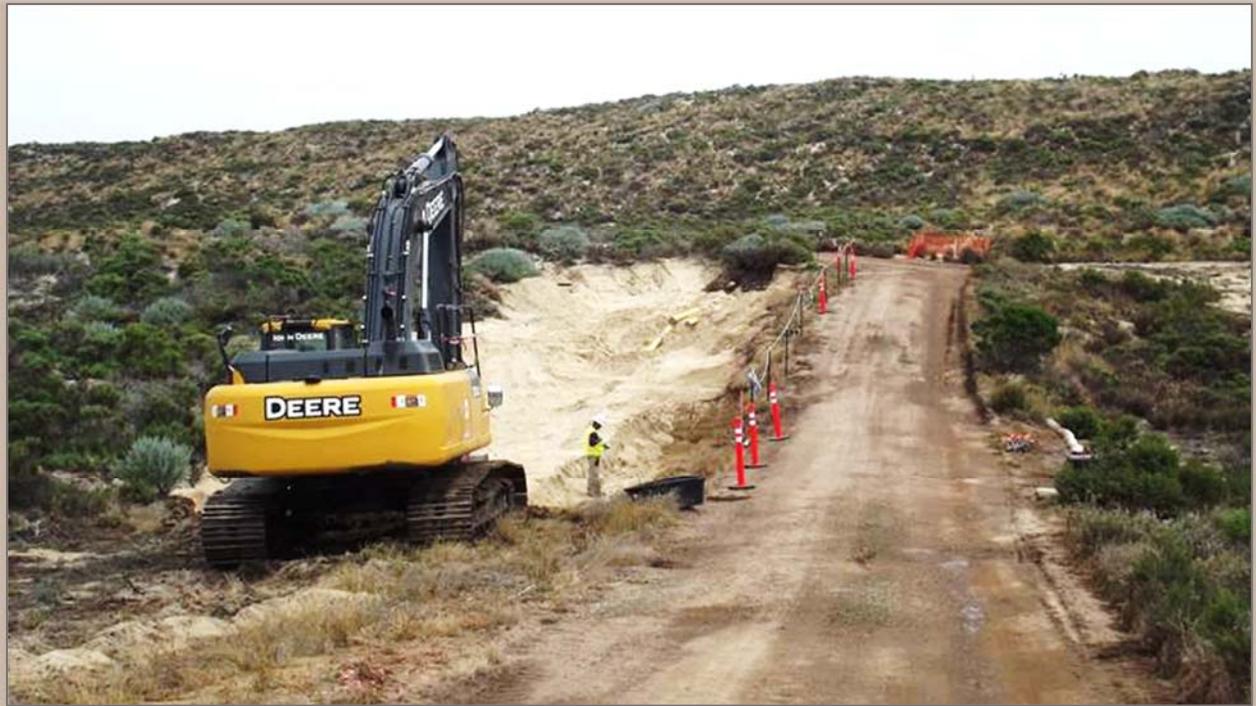
J5A PROS Remediation Site: Same view as previous photo several days later: Chevron contractors continue to excavate sump material, clean, cut, and remove exposed pipeline found during excavation, and excavate exposed diluent stain observed during excavation. After excavation is complete, the site will be sampled and backfilled. Contractors will then install sediment control measures including sand fence and vegetation (originally cut from the site) to help reduce wind and rain erosion from slopes.

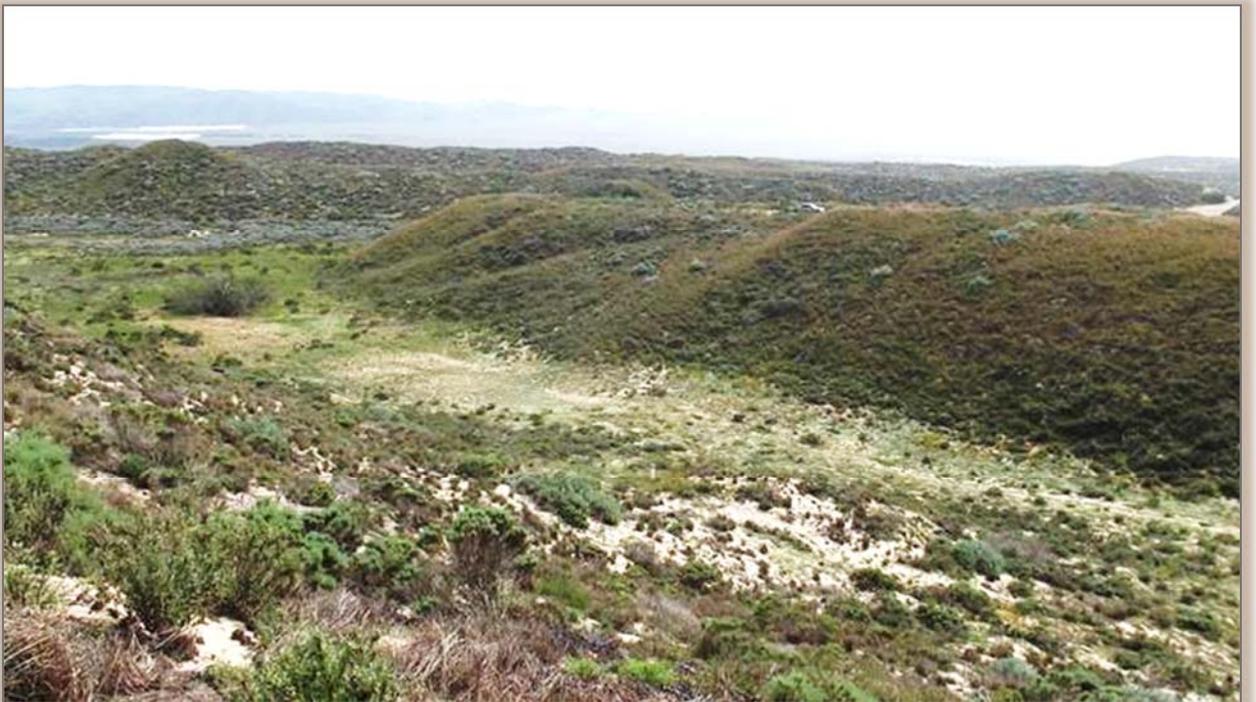
The M1 Valley: prior to remediation activities. The M1 wetland is located on the valley floor and far left portion of the photo. The excavation is proposed to impact approximately two-thirds of the valley floor.

Chevron contractors have begun executing the M1 Remediation Work Plan which includes a partial excavation of diluent-affected material in the M1 valley and the use of a vinyl sheetpile wall.

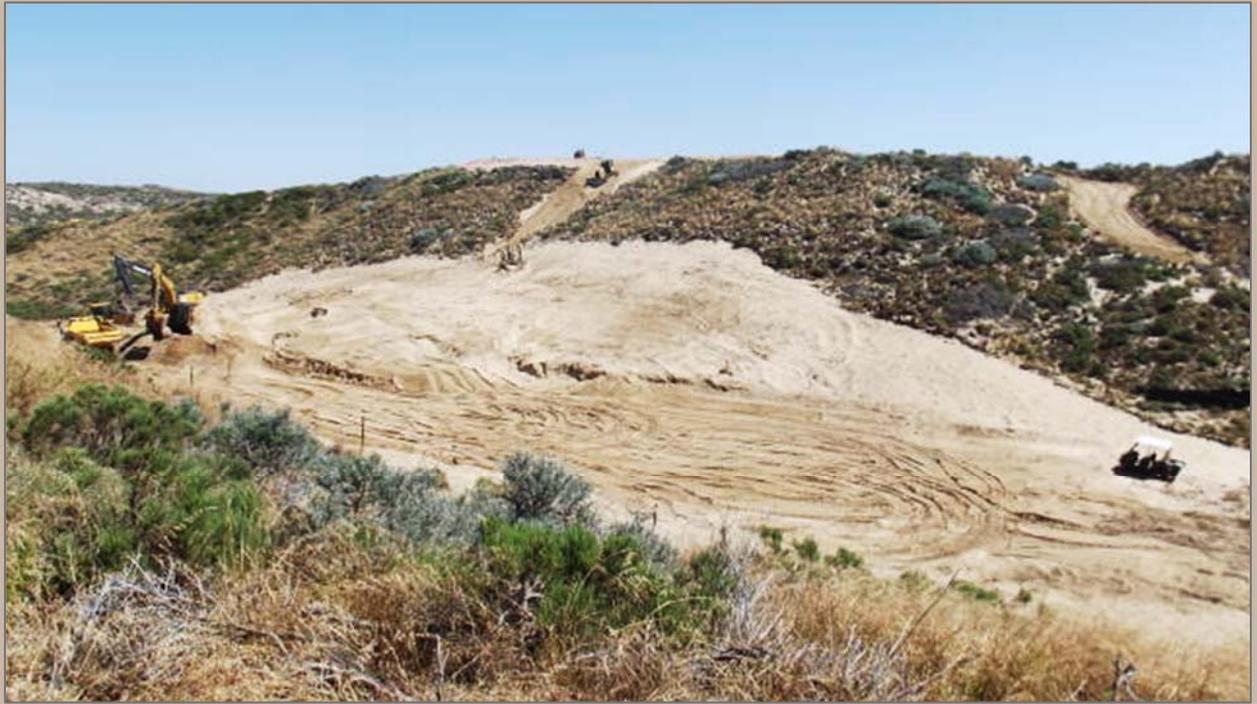
The M1 Valley: vegetation, vegetative overburden and clean overburden being excavated from the site.

- The site has been cleared of all vegetation. Vegetation and vegetative-overburden has been stockpiled at the Q4 and E4A Stockpile locations.
- Entact has excavated all the clean overburden from the site and has hauled it to the Q4 Borrow Site where it will be stockpiled and later, used as backfill for the completed excavation.
- Gregg Drilling has installed dewatering wells and Entact has installed the perimeter sheetpile wall. Dewatering pumps will begin draw-down once the dewatering pipeline system is fully installed, which should occur within the week.
- Chevron anticipates excavation within the sheetpile wall to begin within two weeks.

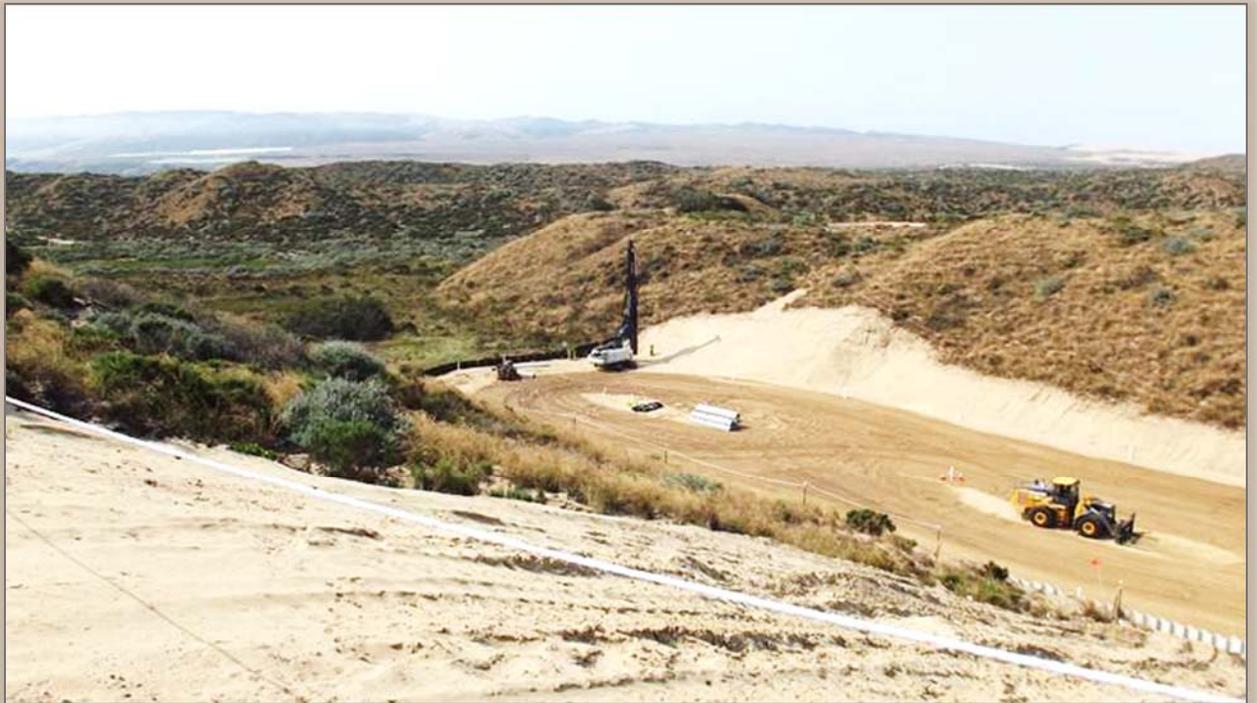
The M1 Valley: sheetpile being installed around perimeter of site.

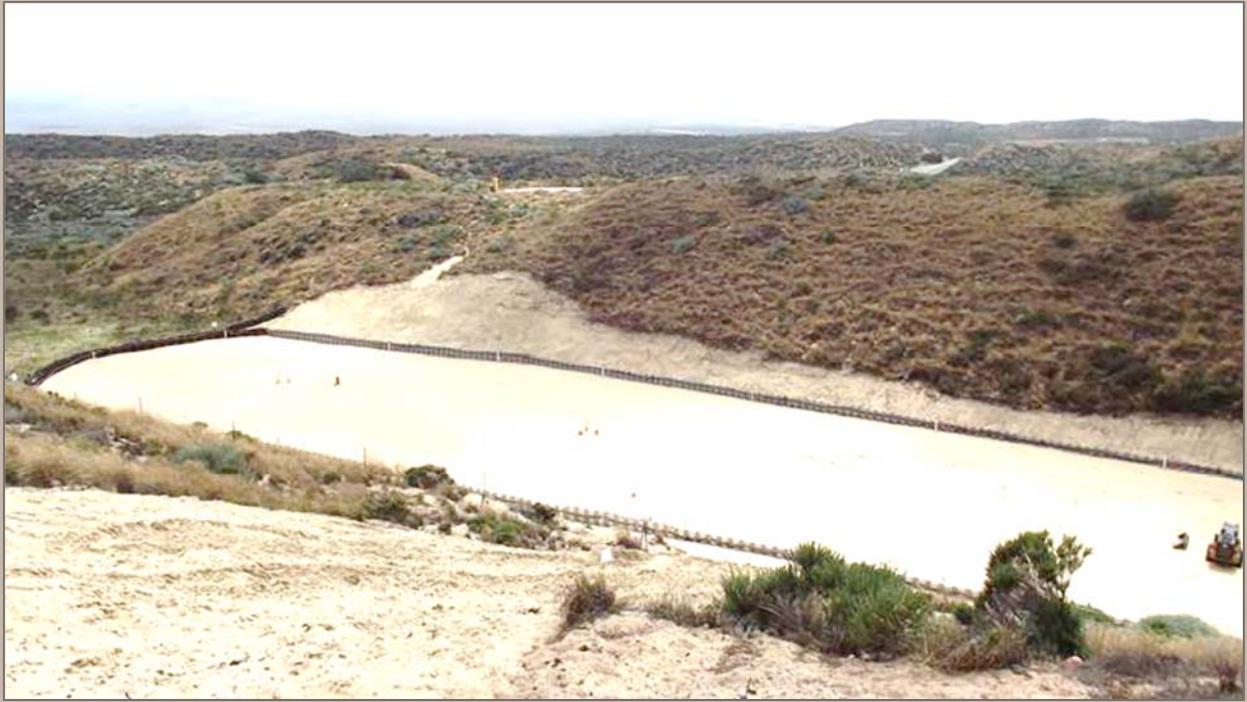
The M1 Valley: both vinyl and steel sheetpile completely installed around site.
