County of San Luis Obispo Onsite Environmental Coordinator
Guadalupe Update 9-20-2017

Construction/remediation activities continue at the Chevron Guadalupe Oil Field Remediation Site (Field) this week. The San Luis Obispo County Onsite Environmental Coordinator (OEC) continues to be present at the Field on a daily basis.

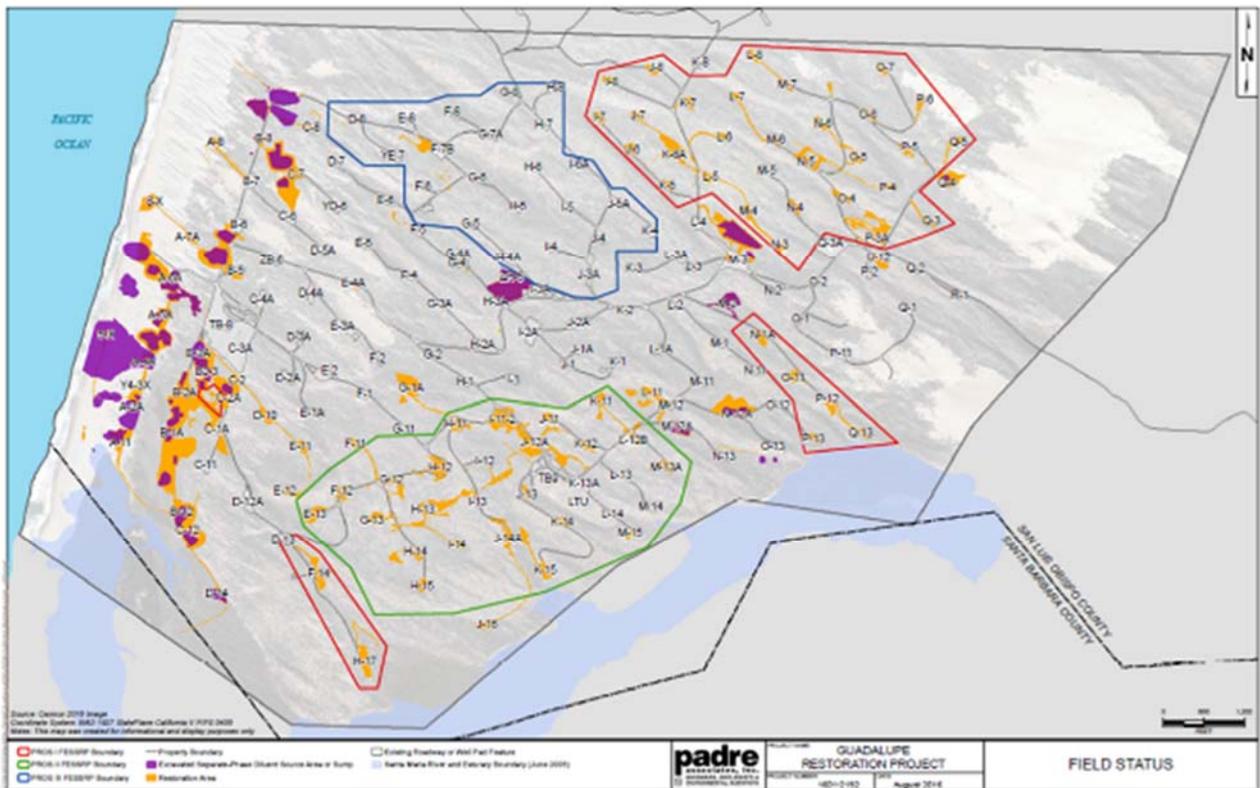
To help orient the placement of remediation activities, Figure 1 shows the Field and the location of all active and completed project sites (including the three PROS Work Plan Phases).

Phase I (Test Phase) Remediation Sites 2013-2015 PROS Sites (outlined in red)
Phase II Remediation Sites 2015-2016 PROS Sites (outlined in green)
Phase III Remediation Sites 2016-2017 PROS Sites (outlined in blue)
Completed remediation sites: excavated separate phase diluent (purple)
Completed PROS sites: excavated and/or treated (gold)

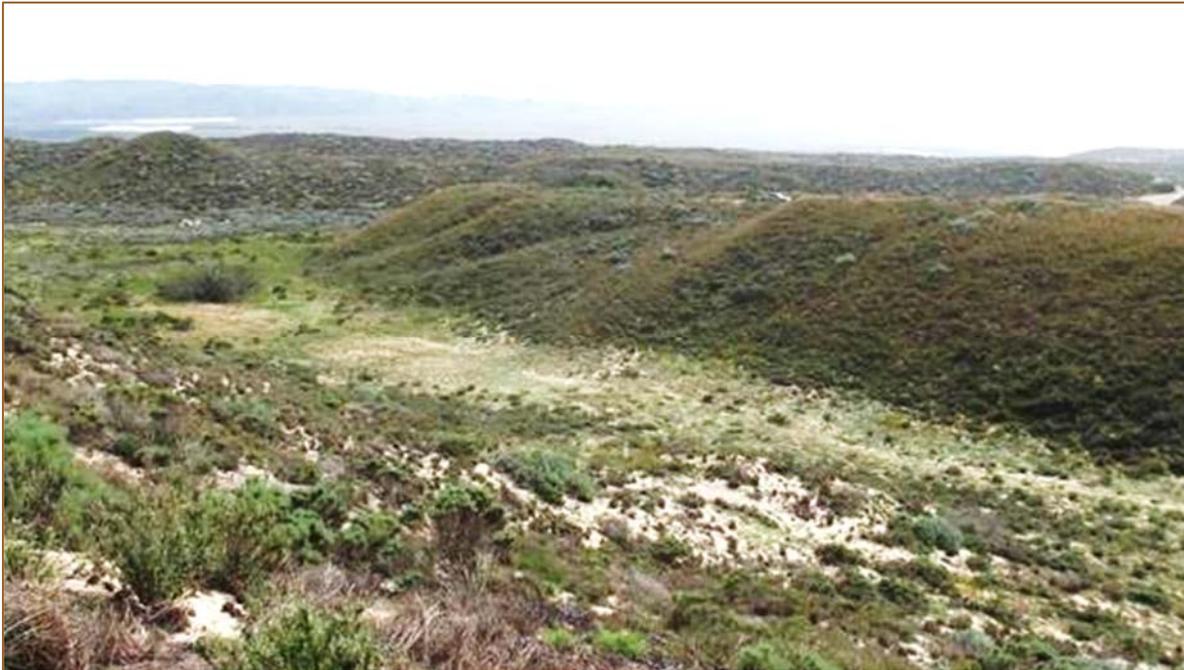
The M1 Valley: prior to remediation activities. The M1 wetland is located on the valley floor and far left portion of the photo. The excavation is impacting approximately two-thirds of the valley floor.

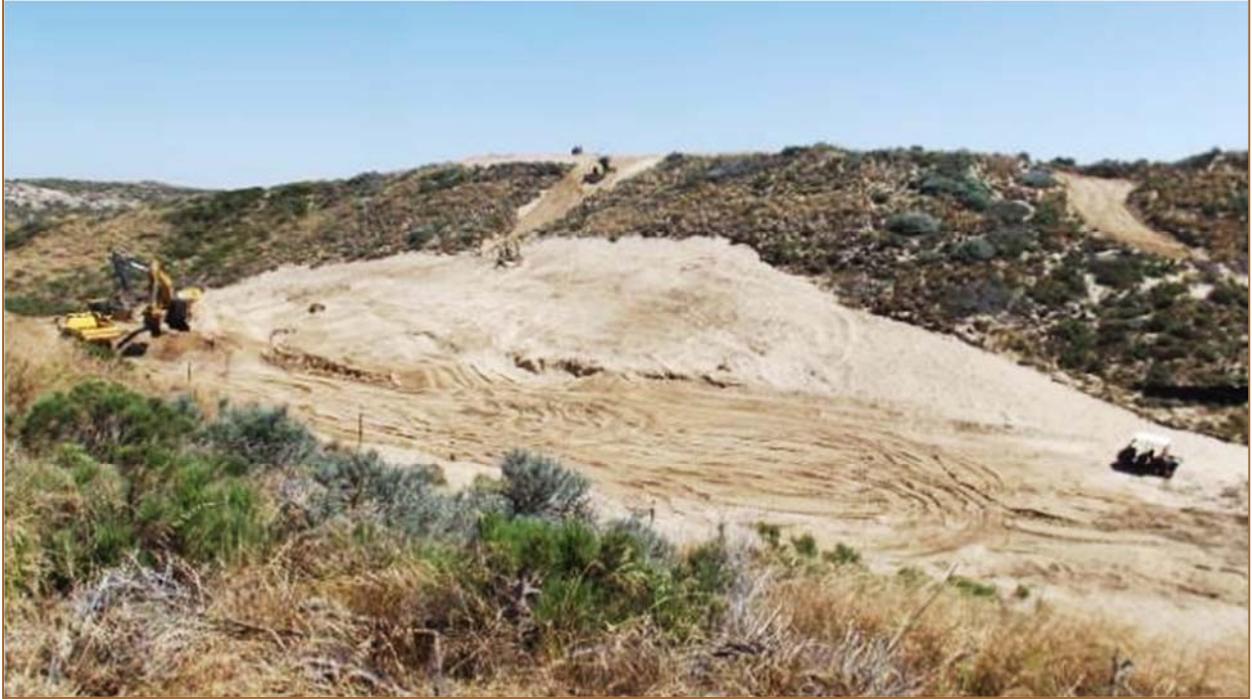
The M1 Valley: vegetation, vegetative overburden and clean overburden being excavated from the site.

- The site has been cleared of all vegetation. Vegetation and vegetative-overburden has been stockpiled at the Q4 and E4A Stockpile locations.
- Entact has excavated all the clean overburden from the site and has hauled it to the Q4 Borrow Site where it will be stockpiled and later, used as backfill for the completed excavation.

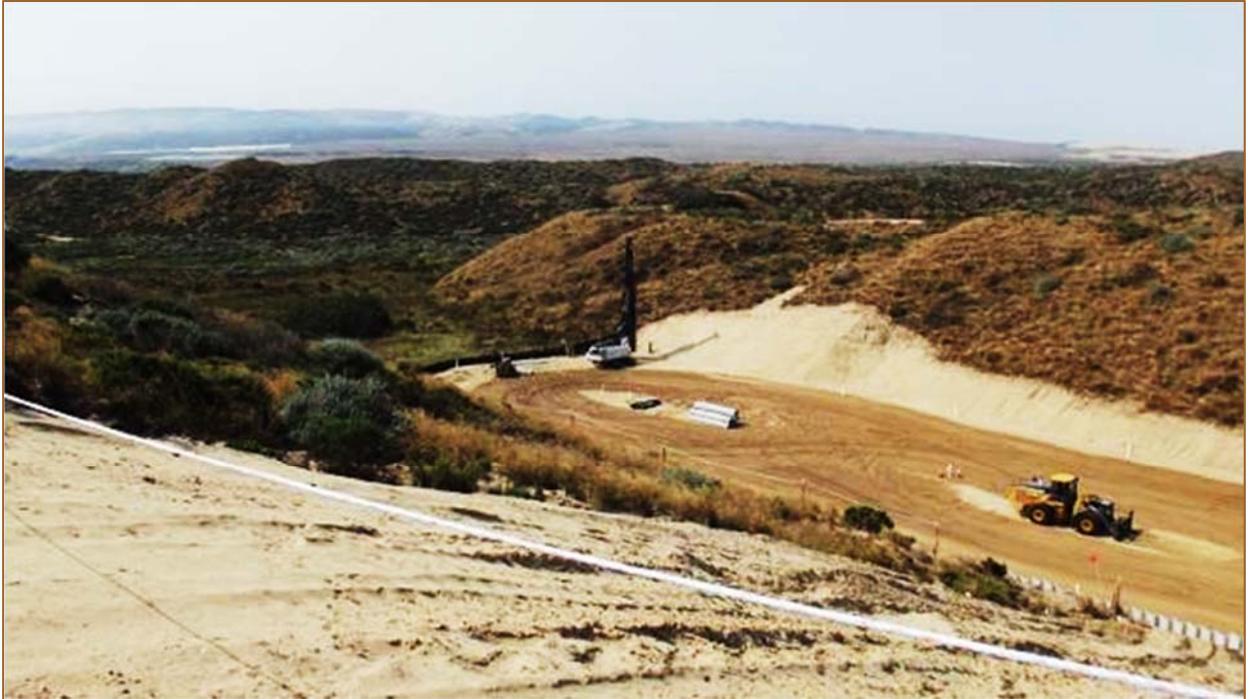
The M1 Valley: sheetpile being installed around perimeter of site.

- Gregg Drilling has installed dewatering wells and Entact has installed the perimeter sheetpile wall and additional sump-pumps. Dewatering pumps have successfully drawn down water levels inside the sheetpile wall.

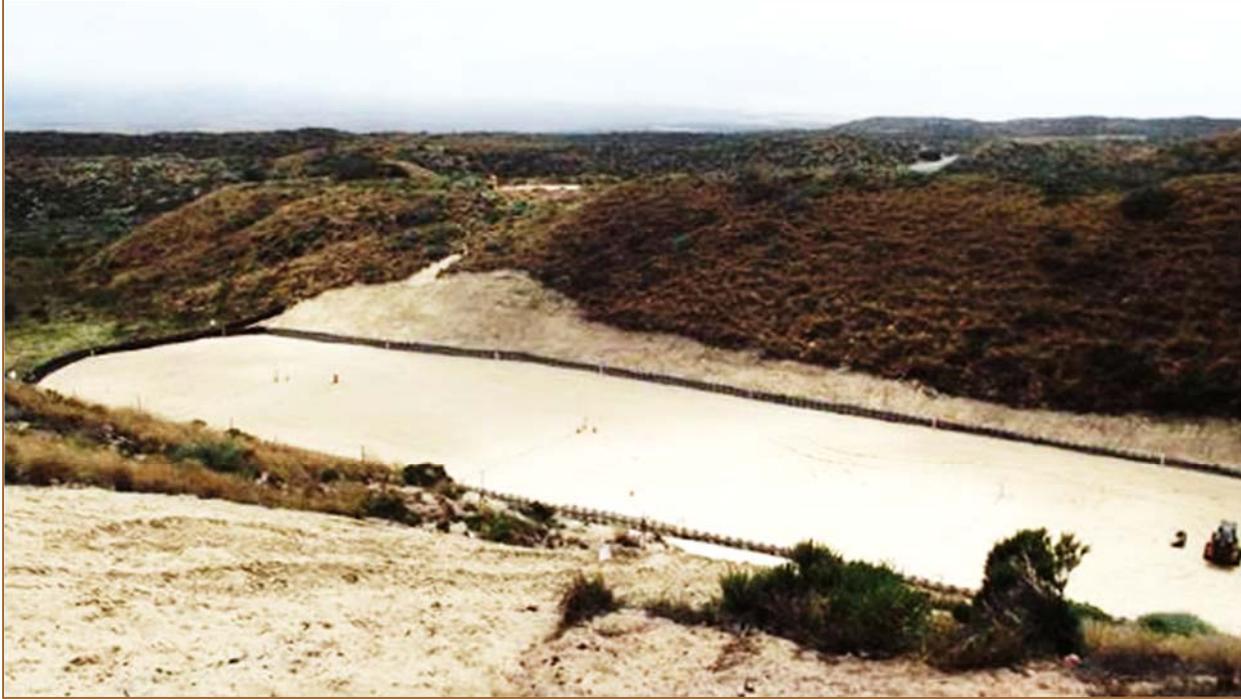
The M1 Valley: both vinyl and steel sheetpile installed completely around the site.

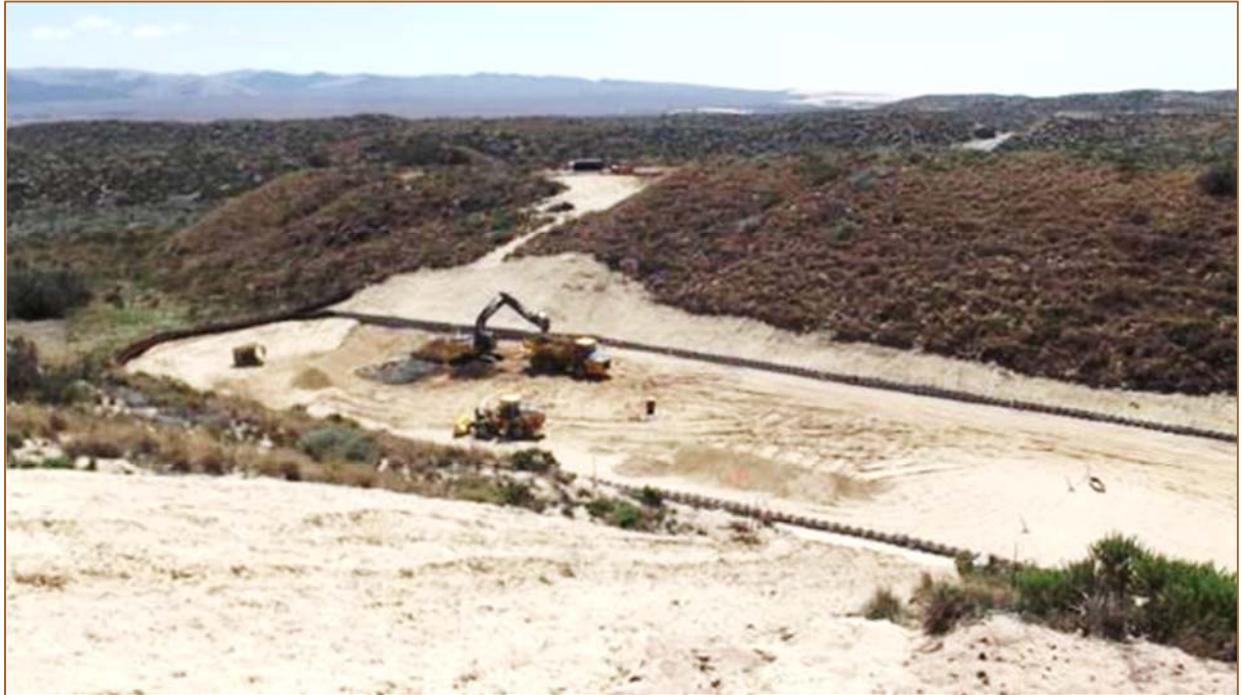
The M1 Valley: excavation of diluent-affected material and temporary backfill to ensure that there is no potential for any wildlife exposure to contaminated soils and no standing water over night.

- Entact has completed excavating diluent-affected soils within the sheetpile wall and hauling material to the TB9 Stockpile.
- Entact has covered the slopes and bottom of the excavation with 1-2 feet of clean sand at the end of each construction work day to ensure that there is no potential for any wildlife exposure to contaminated soils and no standing water.

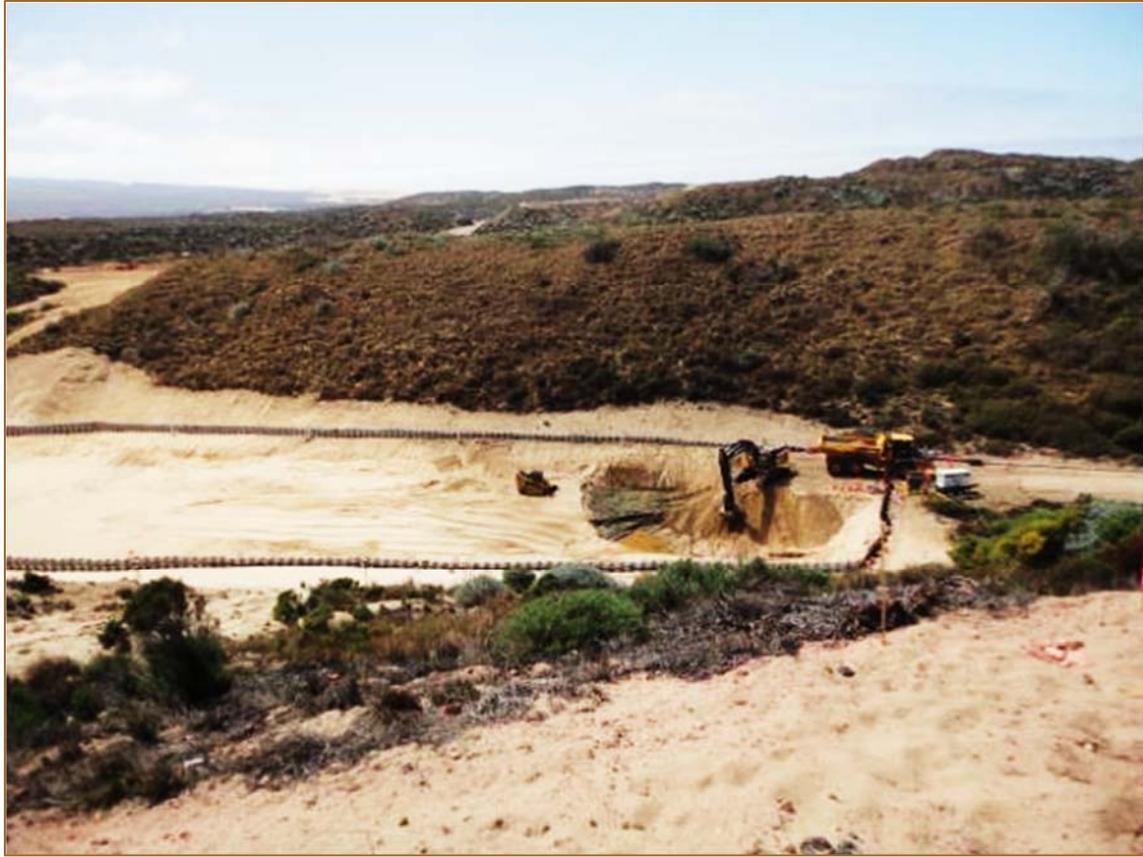
The M1 Valley: excavation of diluent-affected material almost completed. Excavated areas are immediately covered with 6-10 inches of clean sand from the Q4 Borrow Site.

- Padre has collected soil samples and are in the process of analyzing results and requesting backfill approval from the RWQCB. After backfill approval, Entact will (1) backfill the entire site with clean backfill from the Q4 Borrow Site, (2) remove dewatering wells, (3) remove the steel sheetpile walls on the north and south extremes of the cell, (4) cut the vinyl sheetpile wall (which will be left in place) down below final grade, (5) regrade the site to approved elevation and topography, and (6) install final B&P measures (sand fence, vegetative cover, topsoil).

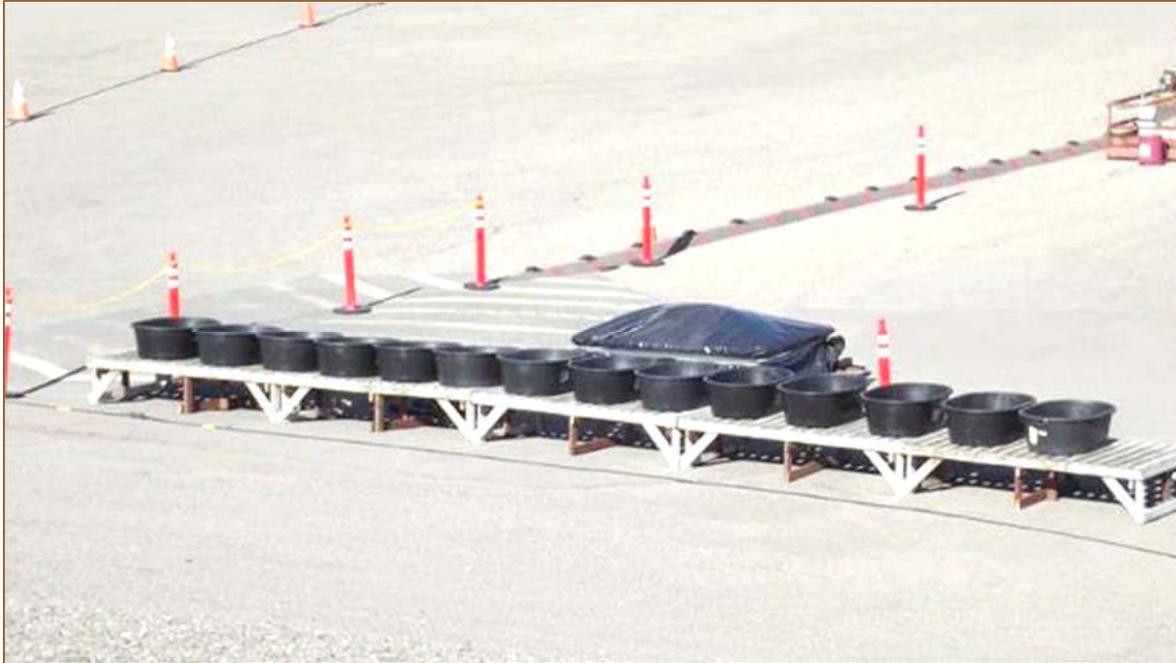
Plastic tubs at the TB8 Stockpile site being used in Chevron's Bench Study of partial/treatment of diluent and sump-affected material. Results will be used in future agency review and discussions concerning the potential TB9/LTU Permanent Treatment or Land Feature.
