**County of San Luis Obispo Onsite Environmental Coordinator  
Guadalupe Update 9-21-2016**

Construction/remediation activities continue at the Chevron Guadalupe Oil Field Remediation Site (Field) this week. The San Luis Obispo County Onsite Environmental Coordinator (OEC) continues to be present at the Field on a daily basis.

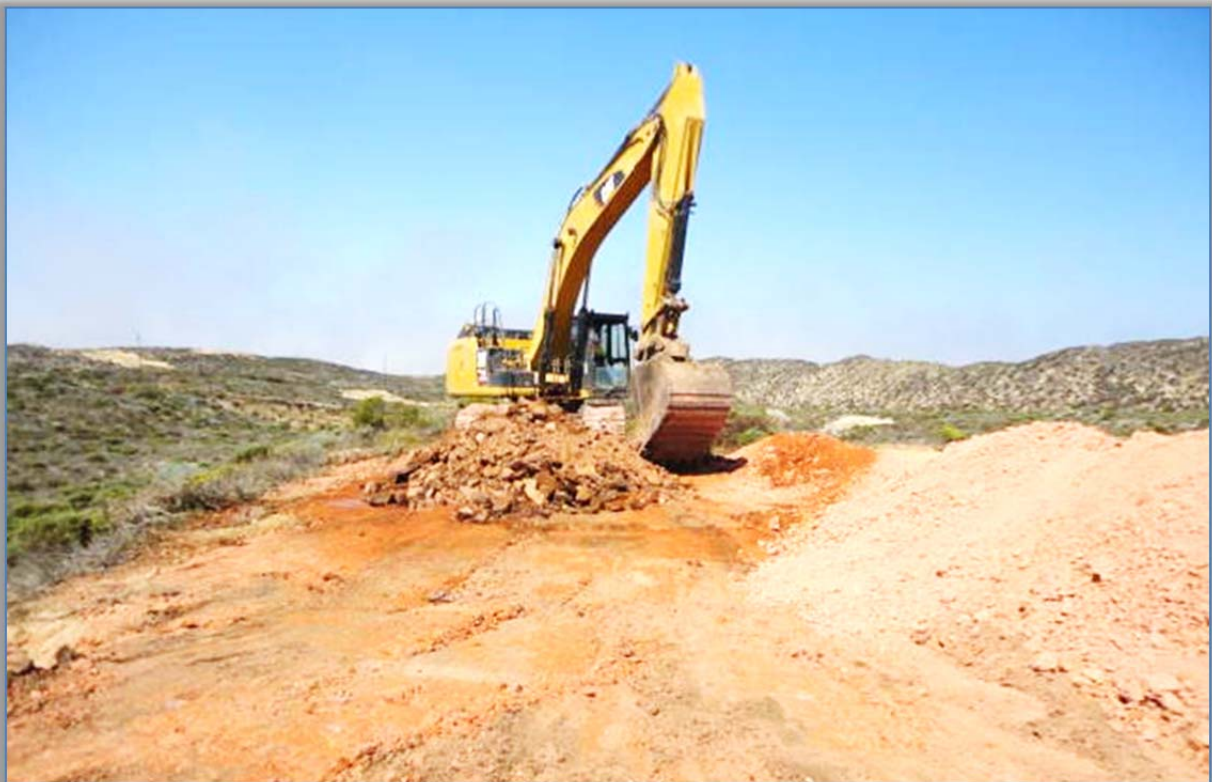
**M14 Road Removal (as part of the final Phase II PROs activities).**

- The Chevron team continues excavation and treatment on several Phase III sites including D8, E8, F7A, G7A and YE7. Excavation, treatment, backfill, final grade approval and the installation of erosion and sediment control measures have been completed at the YE7 Phase III site.
- PROS activities include oil spray removal and treatment, pad treatment, sump removal, pipeline removal, road treatment, asbestos removal and excavation of contaminated materials.
- Chevron has implemented a new backfill approval process that was reviewed and approved by the RWQCB in which portions of a specific PROs Site could be backfilled prior to RWQCB approval. This allows more continuous work flow as the rest of the site is being excavated and/or treated. The OEC will still continue to review all sample data prior to any backfill.

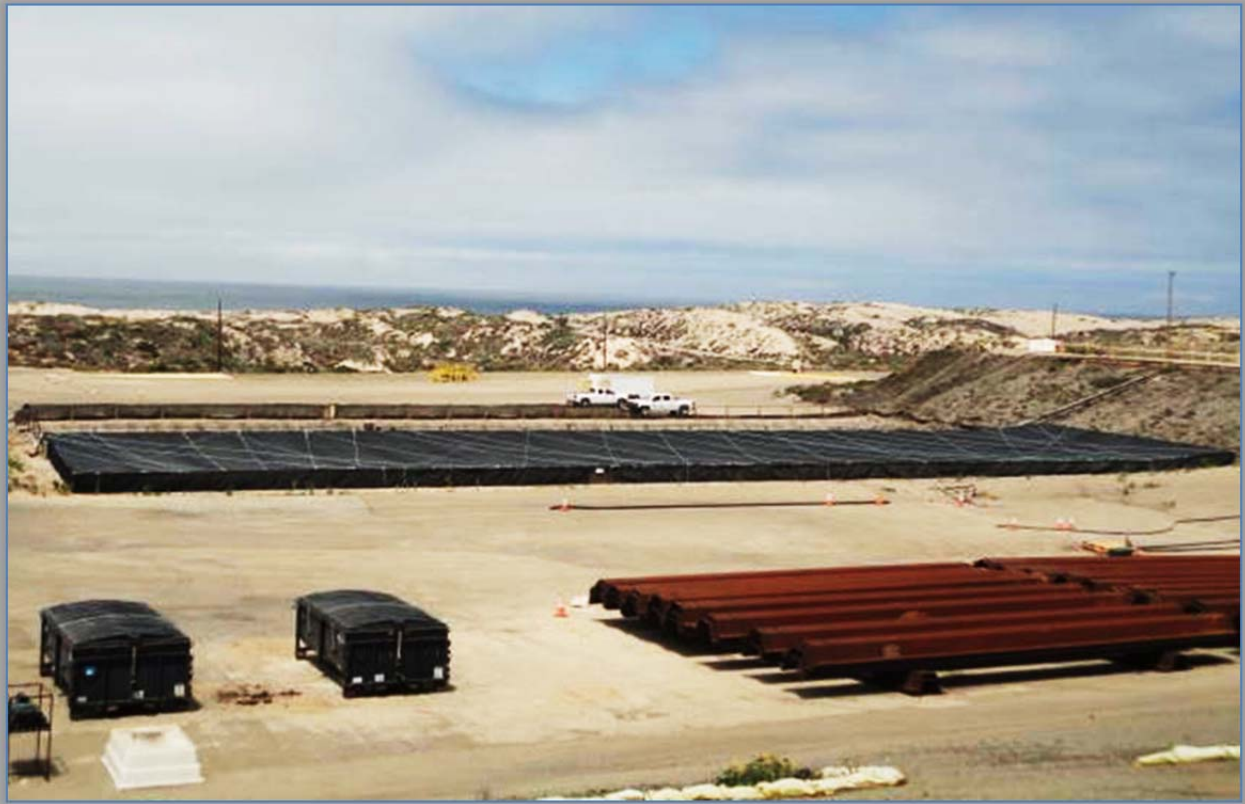
**TB8 Basins: Chevron continues to decommission the TB8 Basins (old view of tarp-covered basins in background). These basins use to contain contaminated water and were responsible for continued potential exposure risks to wildlife. Both basins are now currently backfilled with contaminated material (excavated from the PROS Sites).**

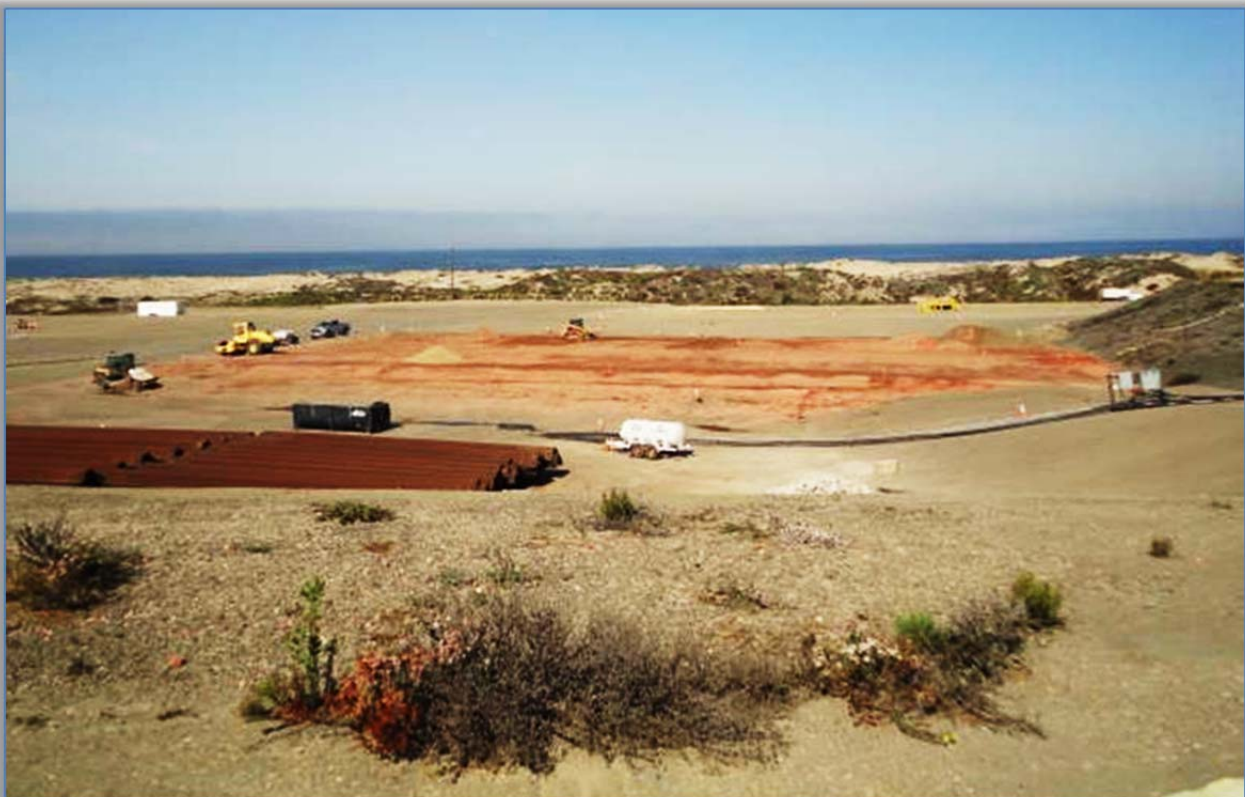
**TB8 Basin: currently backfilled and are being capped with red rock and asphalt to eliminate exposure and storm water runoff concerns.**

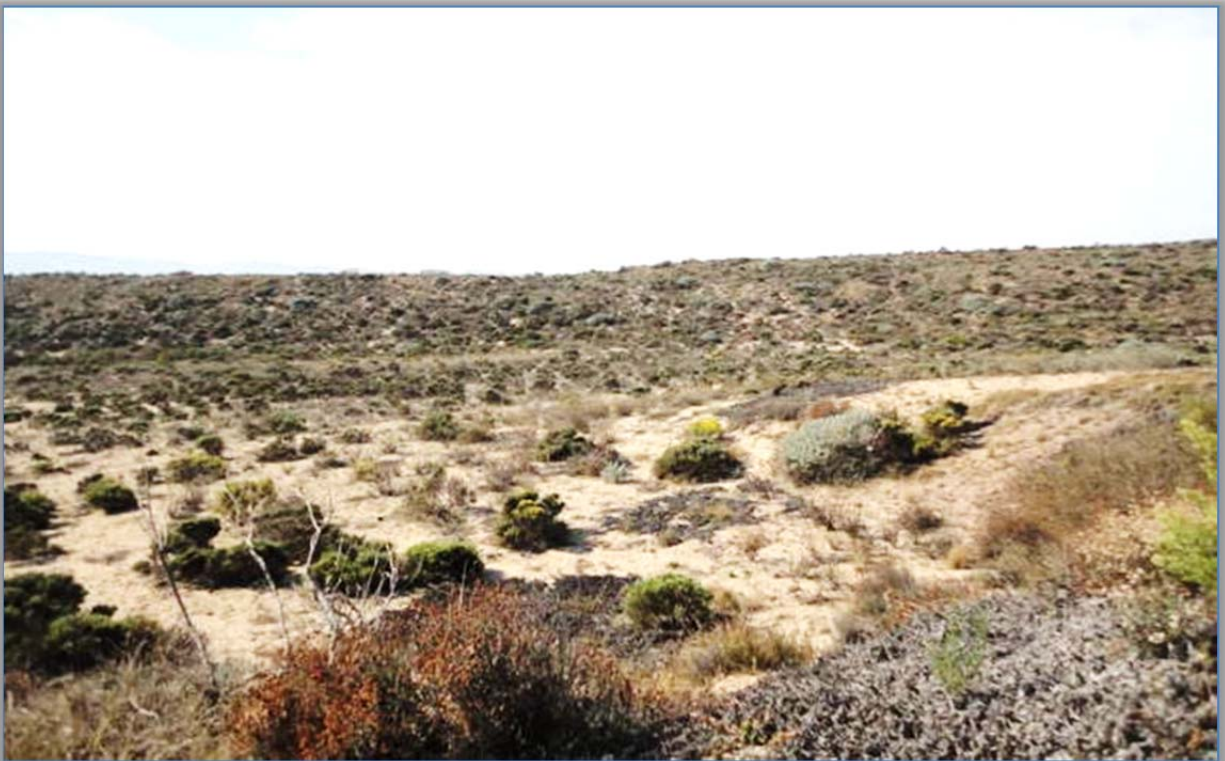
**TB9 (previously the LTU Site): Chevron is proposing to re-activate this previously approved Temporary Stockpile area to stockpile PROs Phase III excavated material. Chevron will be submitting a Work Plan for agency review for this site in the next few weeks.**
