County of San Luis Obispo Onsite Environmental Coordinator
Guadalupe Update 12-8-2016

Construction/remediation activities continue at the Chevron Guadalupe Oil Field Remediation Site (Field) this week. The San Luis Obispo County Onsite Environmental Coordinator (OEC) continues to be present at the Field on a daily basis.

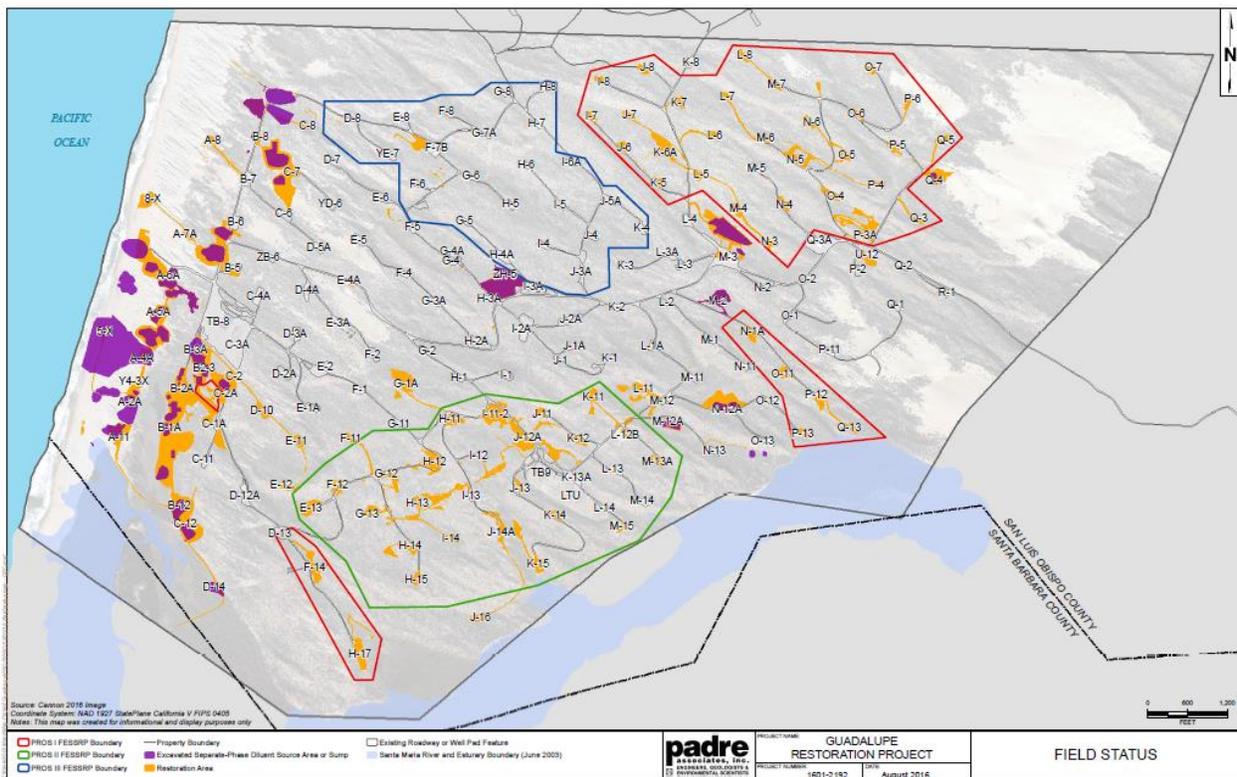
To help orient the placement of remediation activities, Figure 1 shows the Field and the location of all active and completed project sites (including the three PROS Work Plan Phases).

Phase I (Test Phase) Remediation Sites 2013-2015 PROS Sites (outlined in red)
Phase II Remediation Sites 2015-2016 PROS Sites (outlined in green)
Phase III Remediation Sites 2016-2017 PROS Sites (outlined in blue)
Completed remediation sites: excavated separate phase diluent (purple)
Completed PROS sites: excavated and/or treated (gold)

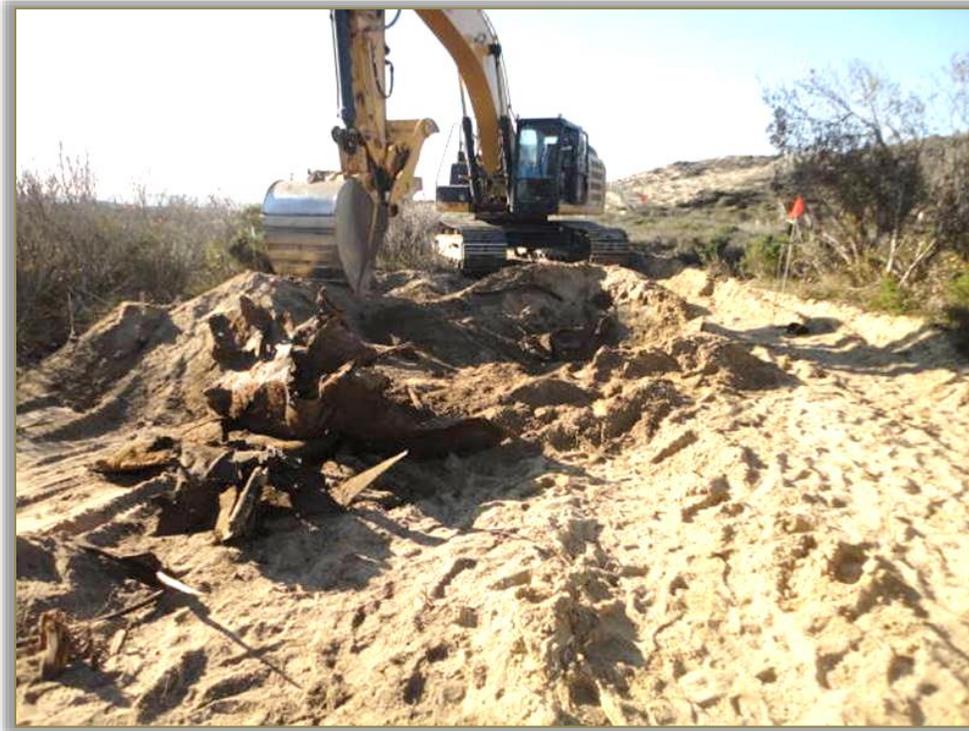
- Excavation of this site began this week. Most of the sump material has been removed and hauled offsite.
- During the excavation of this site, metal debris, tank material, cable and asbestos material was exposed (photo below) and will be excavated in the next two weeks.

B9 Excavation: sump material and metal debris being excavated from the wetland area north of the TB5 Site.

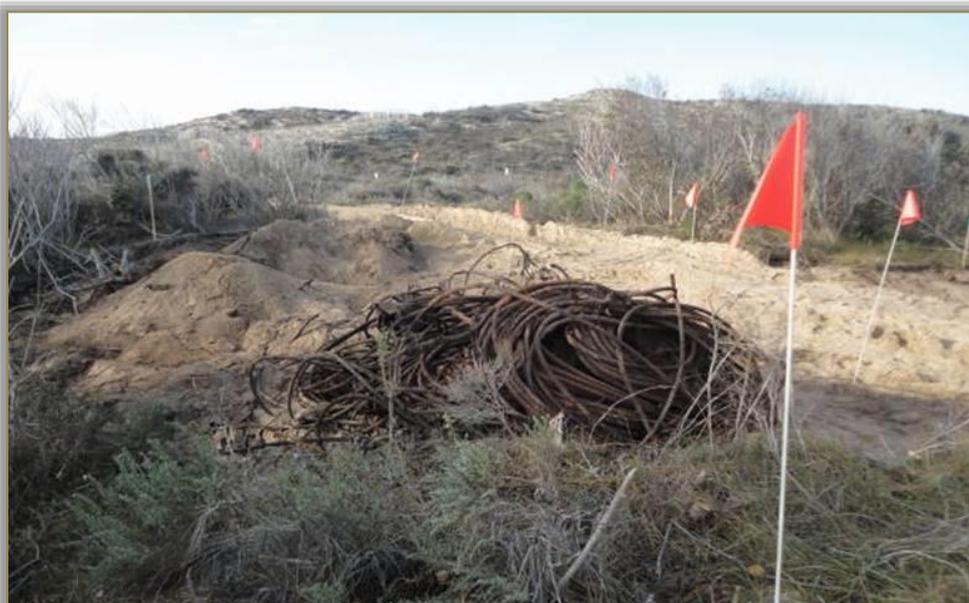
B9 Excavation: metal cable excavated from the wetland area north of the TB5 Site.

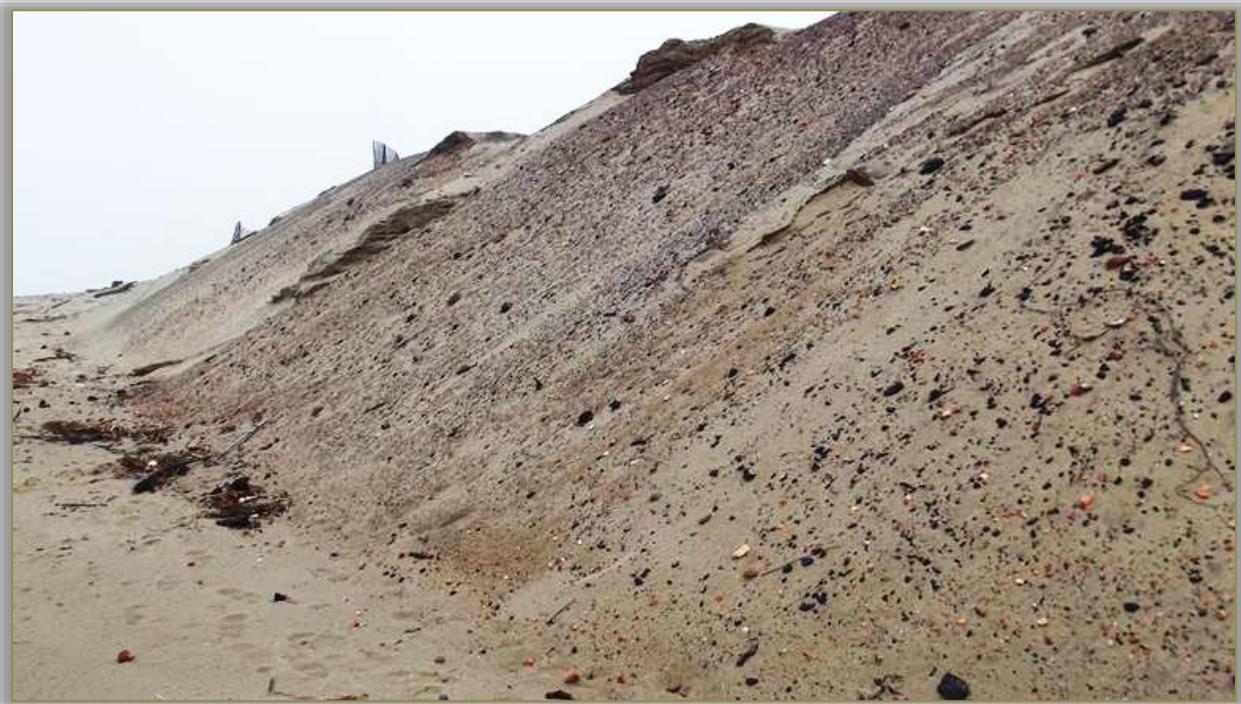
The 8X Beach Area: slope downgradient of the 8X Pad Site. Sump material was previously excavated and removed from this pad site in 2009. Additional sump material was exposed and excavated south of this area last year during the winter season. Winds and tides have continued to erode this Site

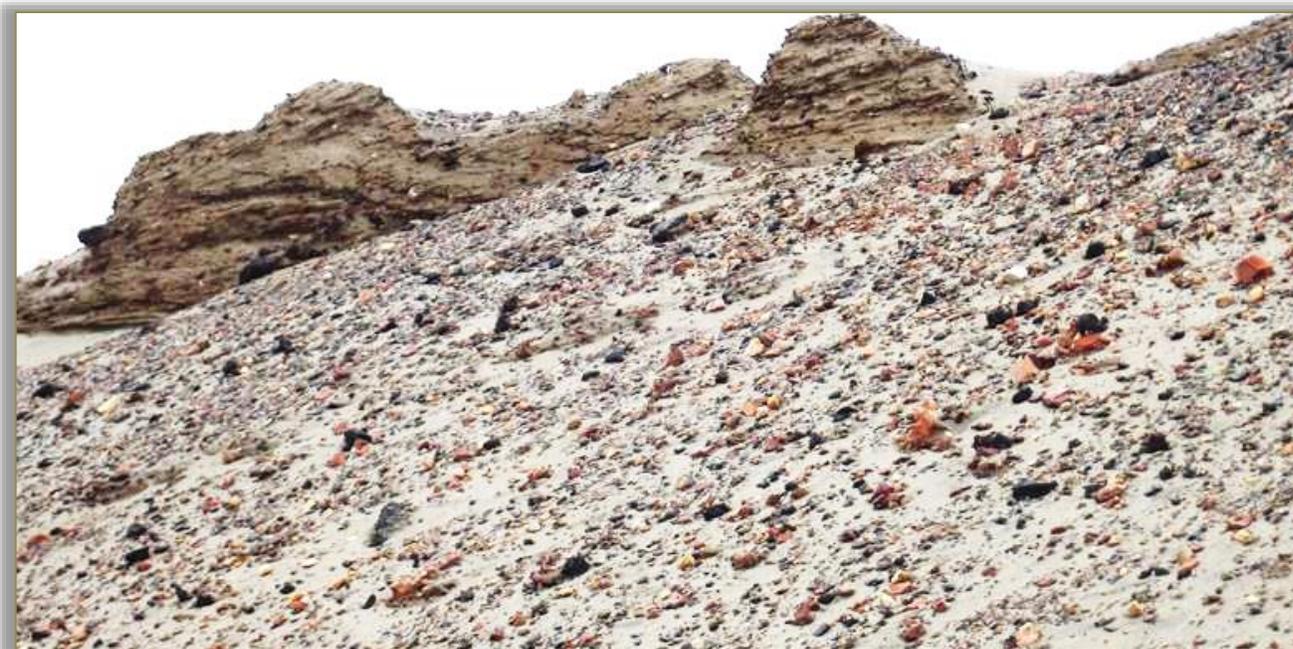
The 8X Beach Area: close-up of downgradient slope off of the 8X Pad Site. Red rock, road base, compacted aggregate base (shown at top of photo) and other road/pad material continues to erode from this pad site into the high-tide zone. No sump material or soluble material has been exposed at this site this season. Chevron continues to monitor the site, remove larger pieces of debris when exposed, and reports that there have been no observations of any release of soluble petroleum material into the ocean.
