County of San Luis Obispo Onsite Environmental Coordinator
Guadalupe Update 12-21-2017

Construction/remediation activities continue at the Chevron Guadalupe Oil Field Remediation Site (Field) this week. The San Luis Obispo County Onsite Environmental Coordinator (OEC) continues to be present at the Field on a daily basis. Construction related activities will temporarily cease for the holiday break from December 22nd through January 3rd.

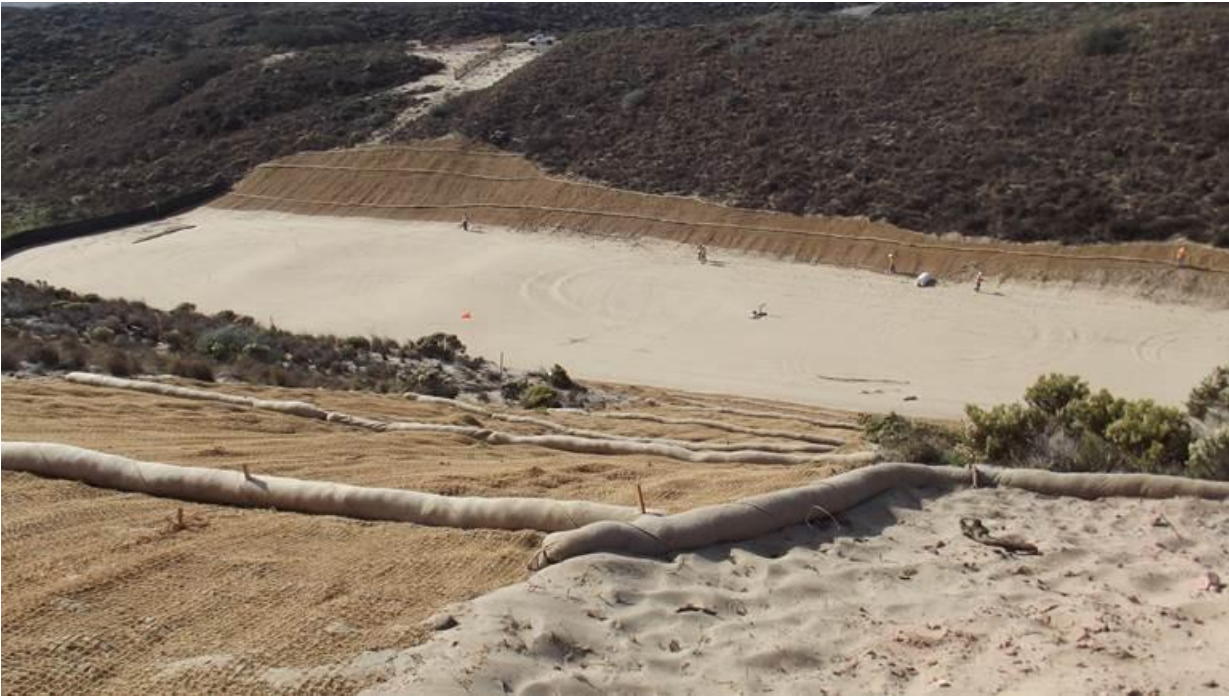
The M1 Valley: backfill along slopes has been completed, B&P measures are currently being installed including: placement of topsoil, jute-netting, sand fence, and application of hydroseed spray.

- Entact has completed excavating, backfill, and regrading most of the slopes surrounding the site.
- Entact has removed the steel sheetpile walls on the east and west extremes of the cell and have cut the vinyl sheetpile wall (which will be left in place) down 2-4 feet below final grade.
- Entact has installed B&P measures including topsoil, jute-netting, sand fence, and hydroseed spray.
- The Chevron team reports that two vinyl sheet interlocks were observed to be partially separated. Chevron has proposed to remedy the separation using hydrated bentonite along the sheetpile interlocks.
- After the final monitoring wells have been installed and vinyl sheetpile wall fixed, the site will be regraded to the approved elevation and topography.

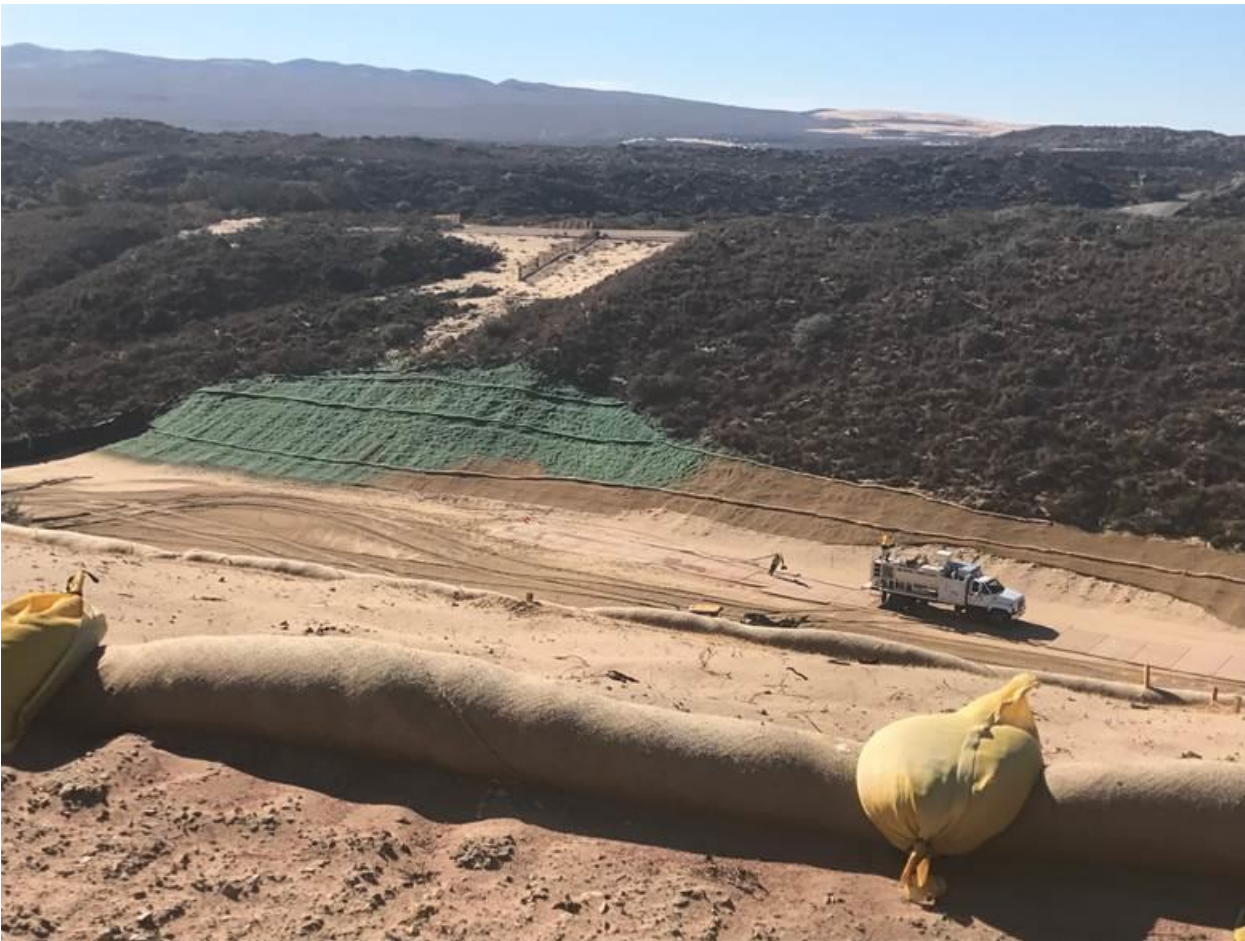
The M1 Valley: hydroseed being sprayed on jute-netting along steeper slopes.

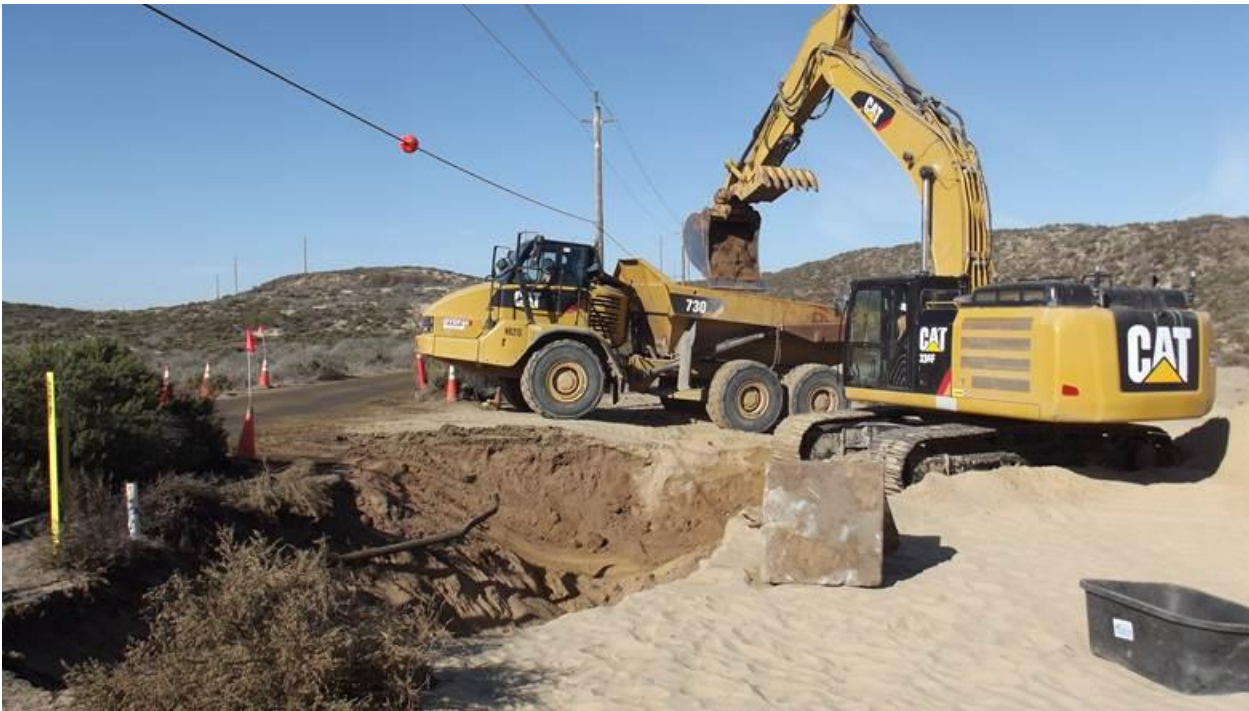
The J11 Site: excavating the last material (a combination of sump and diluent-affected material) from this PROs Phase II site. The area will be backfilled with clean sand from Q4, regraded to natural topography, and then standard B&Ps will be installed to reduce wind erosion.

- The Chevron team continues excavation and treatment on several Phase III sites including the I4, J3A, J4, and J5A sites.
- The Excavation, backfill, final grade approval, and the installation of erosion and sediment control measures have been completed at the J11 Pad Site which is the final PROs Phase II site.
- Excavation, treatment, backfill, final grade approval, and the installation of erosion and sediment control measures have been completed at the following Phase III sites: D8, E8, F7A, F7B, F8, G6, G7, G8, H5, H7, H8, I5, I6A, J4, J5A, K4, L2, M1, M11, N11, and YE7.
- PROS activities include oil spray removal and treatment, pad treatment, sump removal, pipeline removal, road treatment, asbestos removal, and excavation of contaminated materials.
