County of San Luis Obispo Onsite Environmental Coordinator
Guadalupe Update 5-16-2017

Construction/remediation activities continue at the Chevron Guadalupe Oil Field Remediation Site (Field) this week. The San Luis Obispo County Onsite Environmental Coordinator (OEC) continues to be present at the Field on a daily basis.

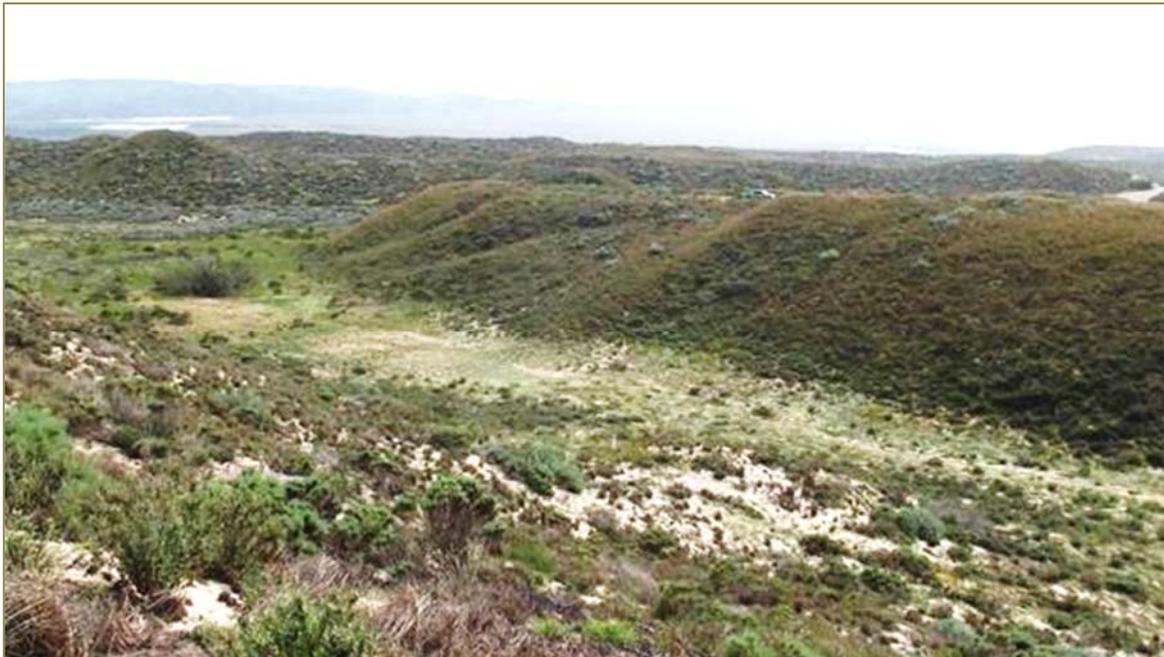
The M1 Valley: location of proposed future remediation activities (currently under agency review) including sheetpile wall, dewatering wells, and partial excavation of diluent-affected soils. The M1 wetland is located on the valley floor and far left portion of the photo. The excavation is proposed to impact approximately two-thirds of the valley floor.

- Chevron submitted the M1 Excavation Work Plan on March 31 for agency review. The remediation plan includes a partial excavation of diluent-affected material in the M1 valley, the use of a vinyl sheetpile wall, and is proposing to leave a portion of the vinyl sheetpile in place after excavation has been completed. Chevron has requested agency review and approval by **today, May 16, 2017.**

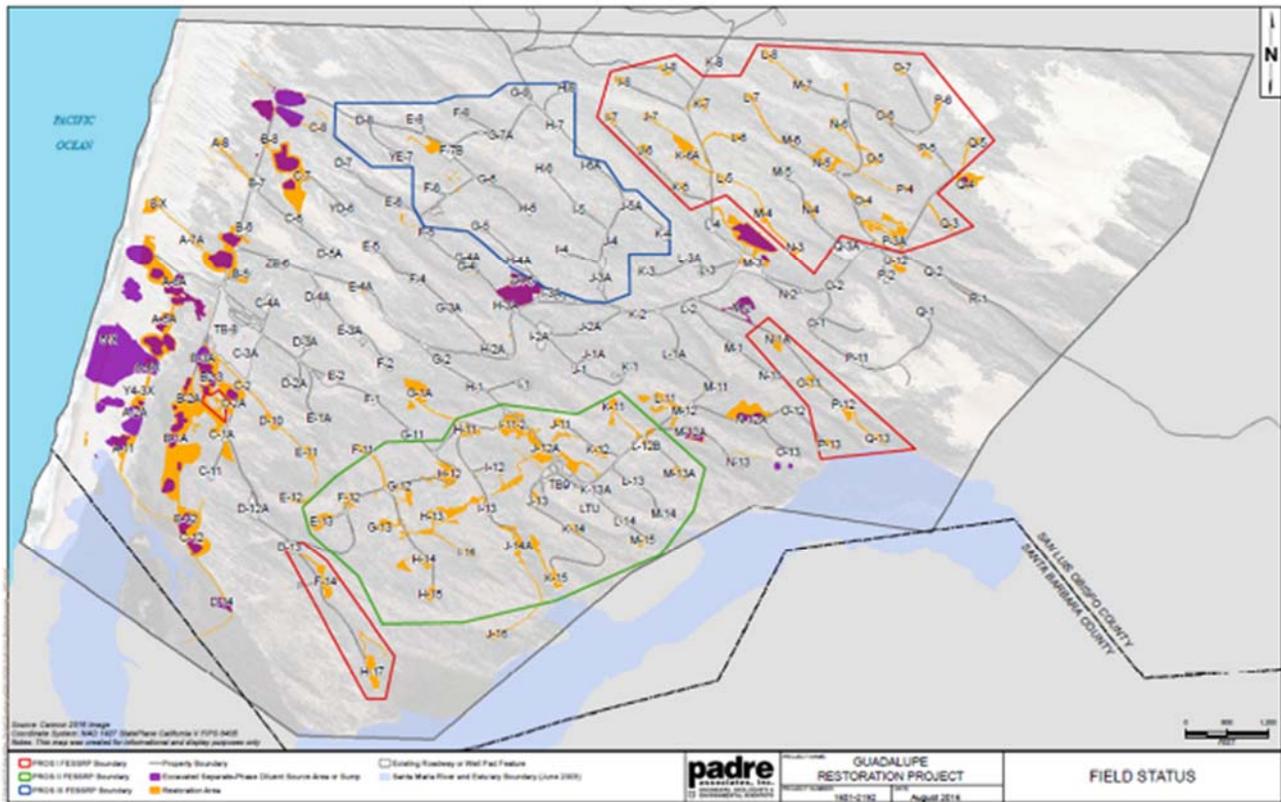
To help orientate the placement of remediation activities, Figure 1 shows the Field and the location of all active and completed project sites (including the three PROS Work Plan Phases).

Phase I (Test Phase) Remediation Sites 2013-2015 PROS Sites (outlined in red)
Phase II Remediation Sites 2015-2016 PROS Sites (outlined in green)
Phase III Remediation Sites 2016-2017 PROS Sites (outlined in blue)
Completed remediation sites: excavated separate phase diluent (purple)
Completed PROS sites: excavated and/or treated (gold)

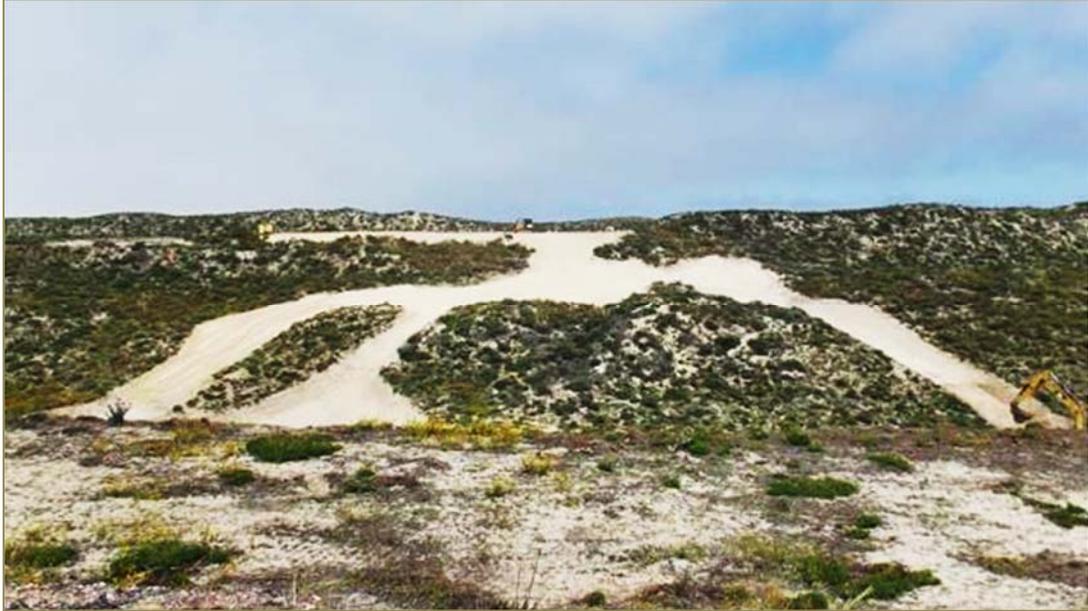
G7 PROS Remediation Site: Chevron contractors completed excavating and grading at this PROS site.

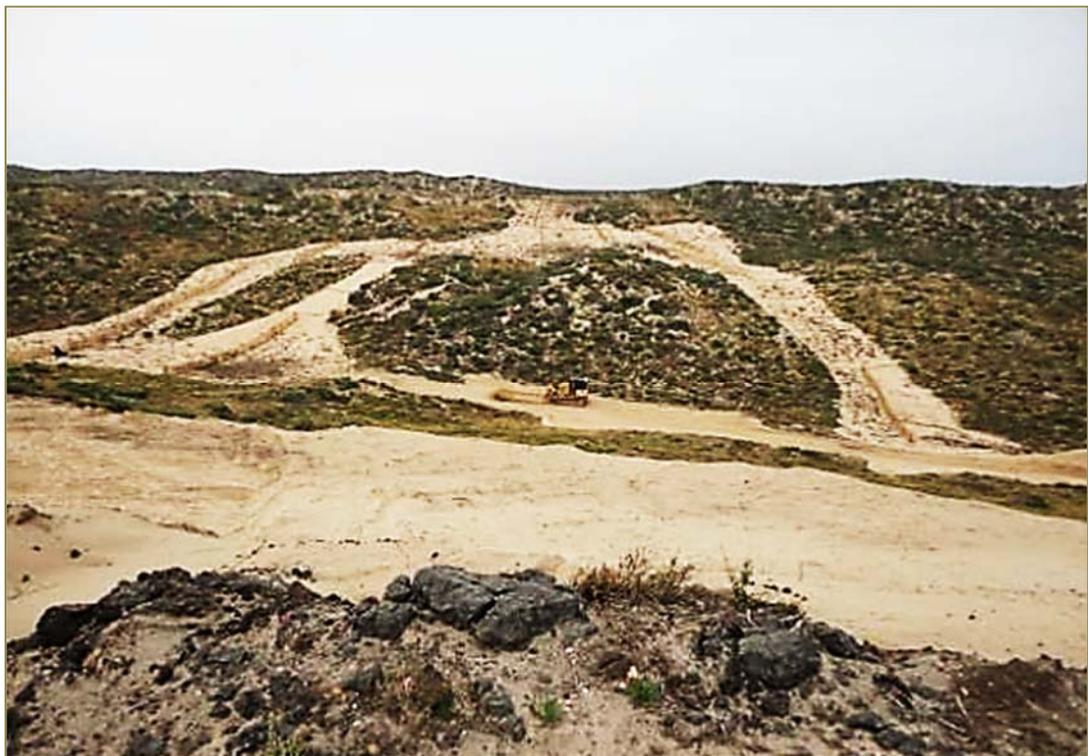
G7 PROS Remediation Site: Same view as previous photo several weeks later: Chevron contractors have completed installing sediment control measures including sand fence and vegetation (originally cut from the site) to help reduce wind and rain erosion from the steep slopes.

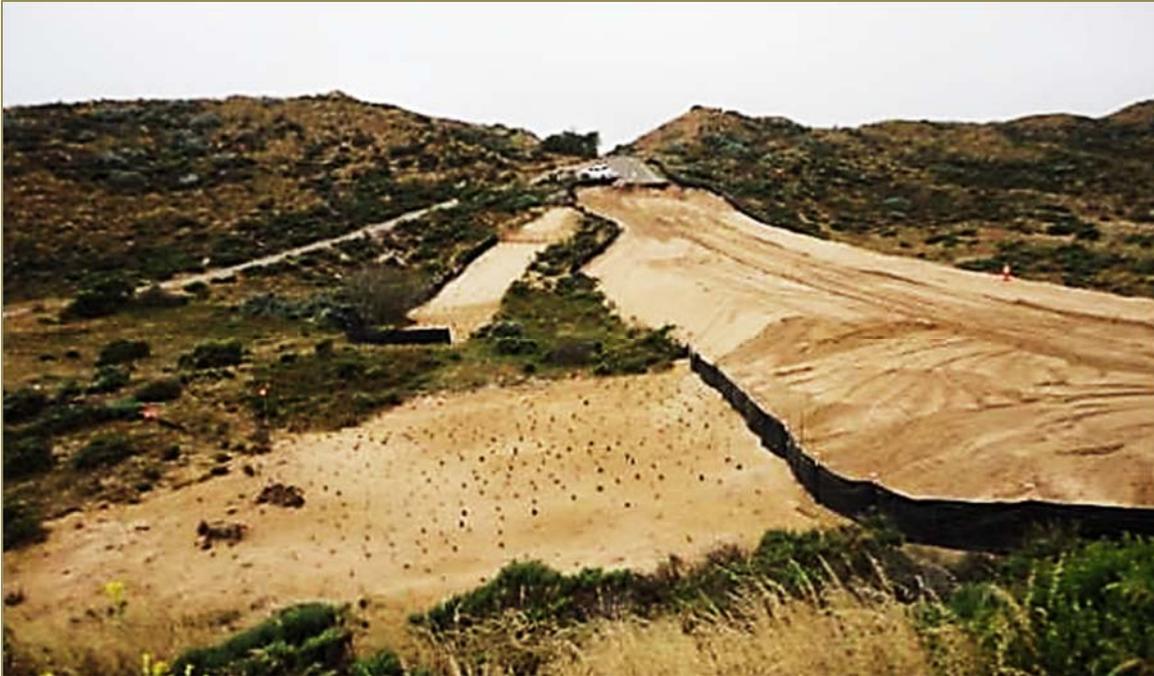
L11 Road Work: Chevron contractors are currently lowering, widening, recompacting, and will soon re-asphalt this portion of the L11 Road to permit haul trucks passage without further road degradation.
